Multi-Engine Turboprop Communiqué**Communiqué ME-TP-0020
June 2020****ATA 25 – AmSafe Crew Seat Belts Connector Web Slide Insert**
Aircraft equipped with AmSafe Crew Seat Belts

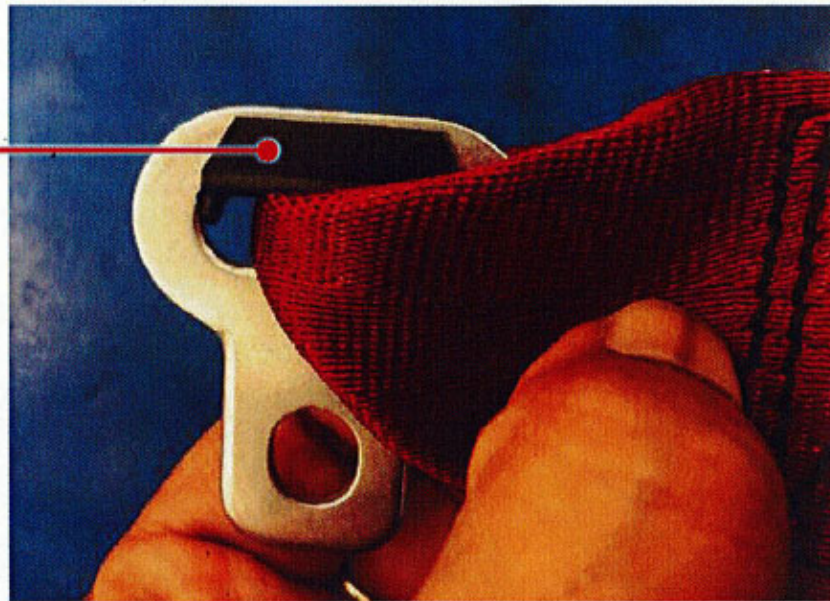
Figure 1. Tongue Web Slide Insert P/N 279213-X

AmSafe has issued Service Letter SL279213 to call attention to the belt connector half assembly tongue web slide where the web slide has been found to be cracked, damaged or missing, see pictures below. The Service Letter provides instructions on how to replace the tongue web slide insert.

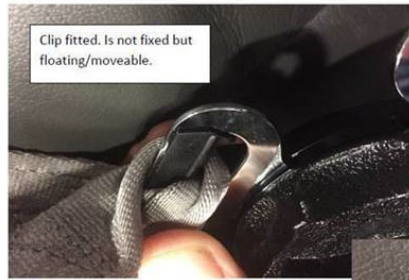
Clip fitted. Is not fixed but floating/moveable.

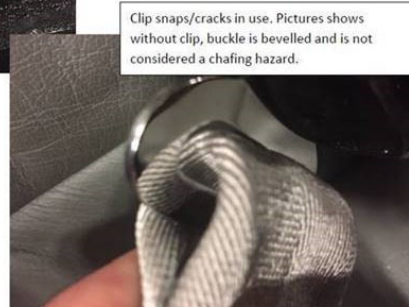
Clip snaps/cracks in use. Pictures shows without clip, buckle is bevelled and is not considered a chafing hazard.
