AIR CONDITIONING - ENVIRONMENTAL SYSTEM WIRING MODIFICATION FOR LOW FLOW IMPROVEMENT

MODEL	SERIAL NUMBERS
Super King Air B200GT	BY-207, BY-239, BY-250 thru BY-381
Super King Air B200CGT	BZ-1

MTB-21-01
Page 1 of 5

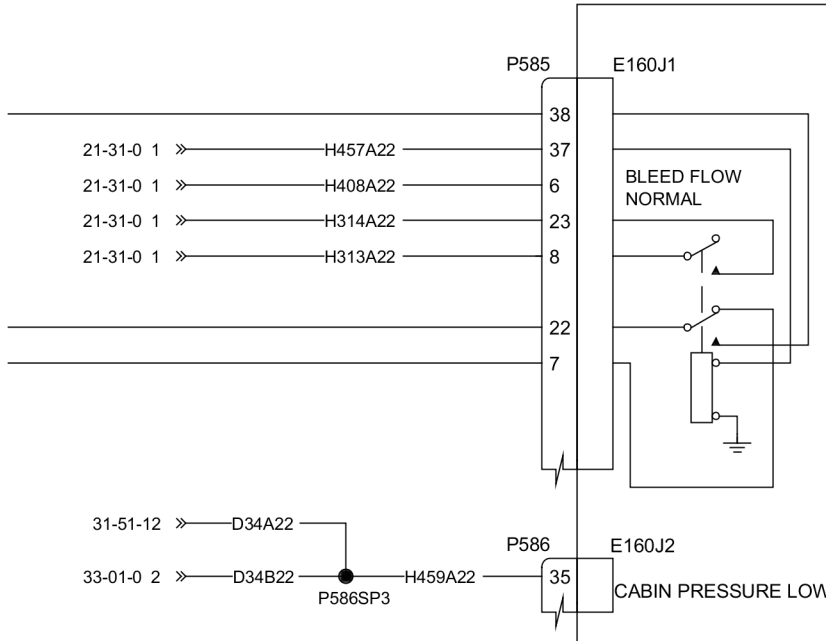
Before Modification

Due to stray voltage, the flow control system will sometimes not run in low flow mode when commanded. Environmental system requires diode isolation to allow operation in Low Flow setting. Without this change, system may continue running in Hi Flow regardless of setting.

3. Do the wiring modification.
 - A. Cut the D34A22 Wire.
 - B. Slide the 106242G44-00400 Heat Shrink Tubing onto the D34A22 Wire.
 - C. (Refer to Figure 1.) Install the 132408-22 Diode on the D34A22 Wire with two M81824/1-2 Splices. (Refer to the King Air Standard Practice Chapter 20 – Airframe, Electrical Wiring – Maintenance Practices).

- D. Install the 106242G44-00400 Heat Shrink Tubing over the Diode.
 - E. Use the heat gun to heat and shrink tubing.
4. Remove the maintenance warning tags and connect the airplane battery.

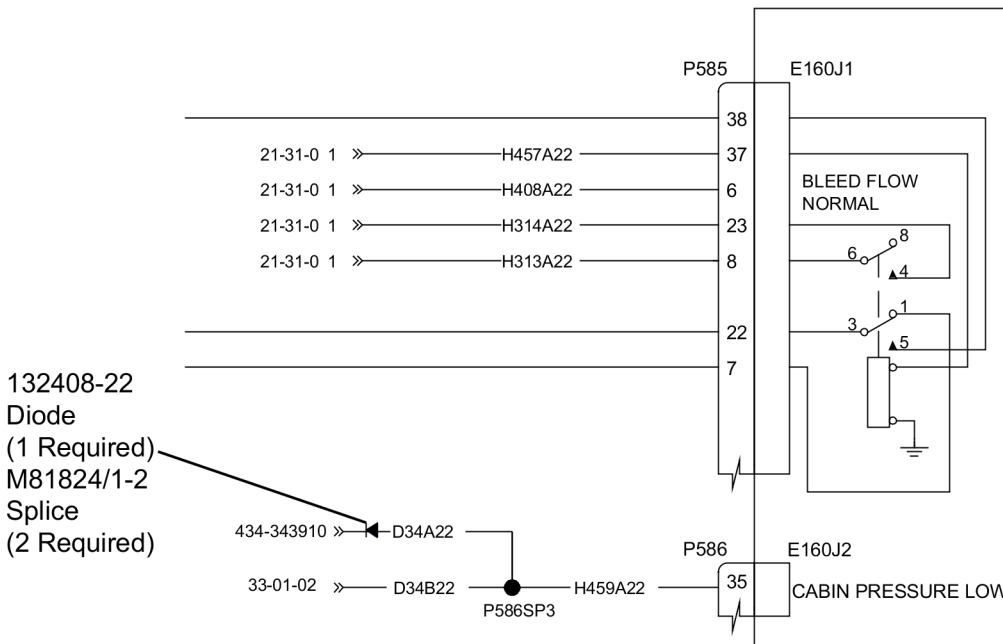
After Modification

Figure 1. Low Flow Improvement Wiring Modification (Sheet 1)
