**MANDATORY****MEL-71-04****TITLE**

POWER PLANT - TRANSMITTAL OF CONTINENTAL SB 19-07 - CRANKSHAFT END PLAY CHECK

G58

**TECHNICAL PORTIONS  
FAA APPROVED****SUBJECT:** Crankshaft End Play Check**PURPOSE:** Recommended crankshaft end play inspection for installed engines**COMPLIANCE:** Perform inspection no later than the next scheduled 100-Hour/Annual inspection.**MODELS****AFFECTED:** Continental O-200, IO-240, IO-360, TSIO-360, O-470, IO-470, GTSIO-520, IO-520, TSIO-520, IO-550, TSIO-550 aviation gasoline (AvGas) engines identified by serial number in Table 1, Affected Engines**I. GENERAL INFORMATION**

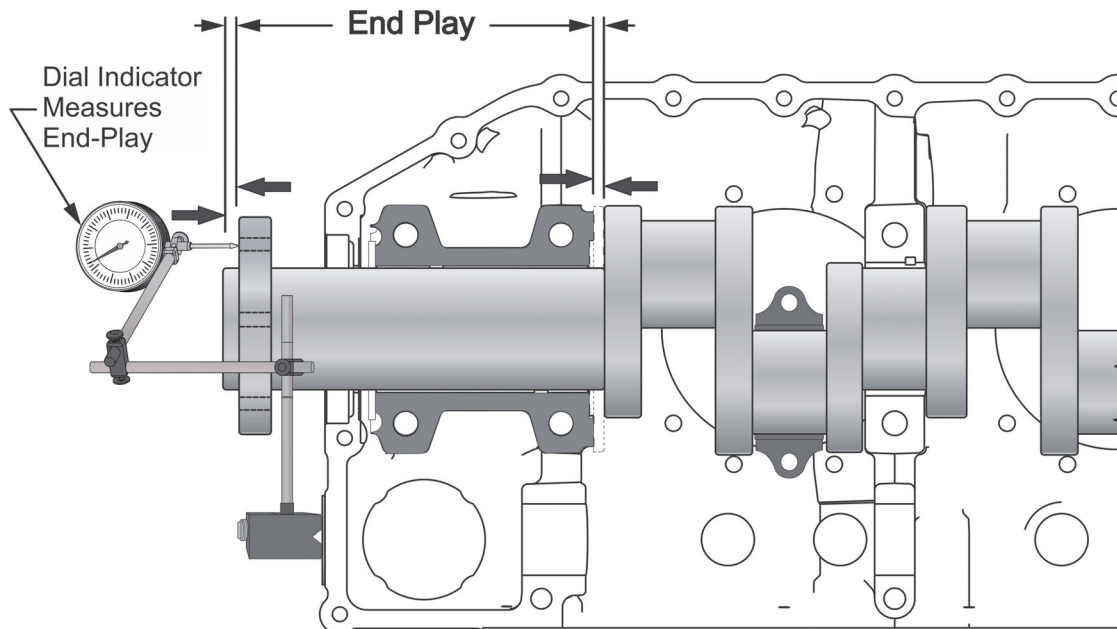
**Figure 1. Measuring End Play (section view, for reference only)**

Continental Aerospace Technologies™ (Continental®) has seen evidence of excessive crankshaft end play for a limited production of engines (reference Table 1 on page 2) produced between 1 OCT 2018 and 1 JAN 2019. Continental employs a crankcase thrust washer design to reduce wear directly on the crankcase thrust face surface. Crankshaft “end play” is measured as the clearance between the crankcase thrust washer and the axial mating surface of the crankshaft (see Figure 1).

NOTE: Crankshaft end play is to be measured in an assembled and torqued crankcase. Figure 1 section view is representative and should be used for reference only.

1. Secure a dial indicator (M-0, Standard Practice Maintenance Manual, Chapter 2-1) to the front of the crankcase (see Figure 1, the magnetic base shown is for reference only).
  - a. If vertical surface attached to the crankcase is accessible (spinner back plate, De-ice ring, rear of crankshaft prop flange, etc.), the inspection can be performed without removing the propeller.
  - b. If mounting the dial indicator can not be properly achieved without removing the propeller, the propeller must be removed.

2. Move the crankshaft to the rear of the engine as far as possible.
3. Position the dial indicator gauge head (contact point) to the vertical face of the crankshaft prop flange (see Figure 1) or an accessible vertical surface attached to the crankshaft prop flange and set the gage to read “0.”

4. Slide the crankshaft to the front of the engine as far as possible.
5. Record dial indicator end play measurement.
  - a. If end play exceeds the limits defined in Table 2, it may be necessary to disassemble the crankcase and examine the crankcase and/or crankshaft for wear, damage, or to replace any unserviceable components. Contact Continental Customer Service Department directly at 1(800) 326-0089 for further instructions.
