TEXTRON AVIATION

# Multi-Engine Turboprop Communiqué

Communiqué # ME-TP-001 Rev 1

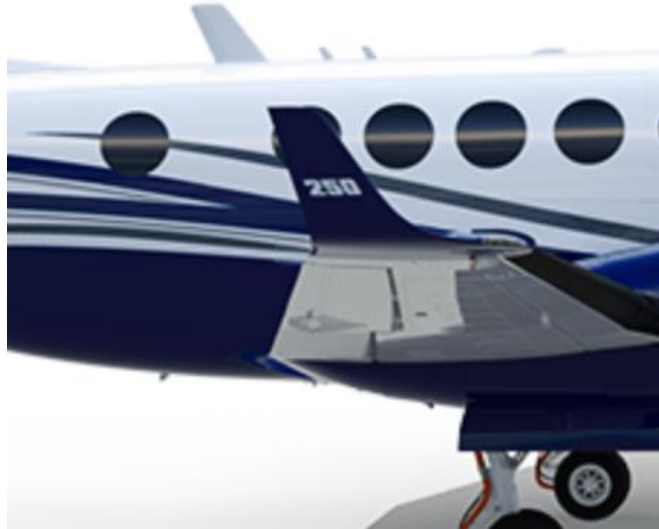
## ATA 11 - King Air "250" and "350" Winglet Placard

The King Air "250" placard installed on the outboard side of the winglets does not have an official published part number. If the placard needs to be replaced please place your order for the replacement via email to [parts\\_research@txtav.com](mailto:parts_research@txtav.com).

**Rev 1. The email address to order this placard has changed to [teamturboprop@txtav.com](mailto:teamturboprop@txtav.com)**

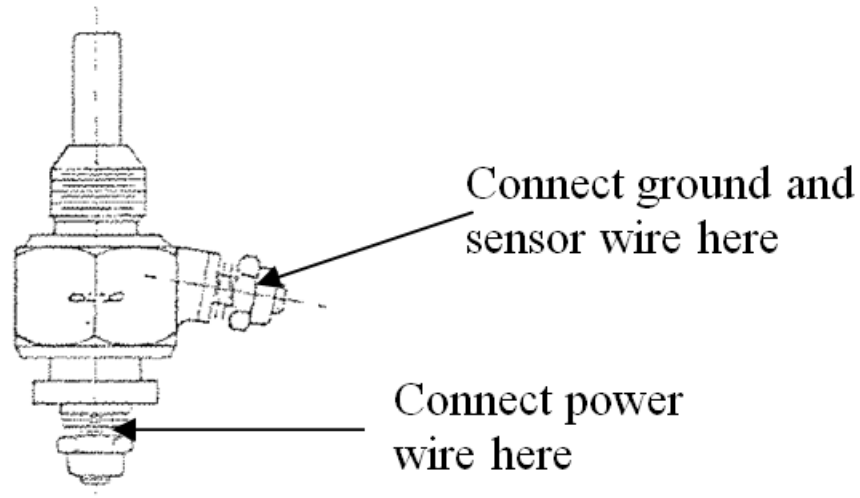
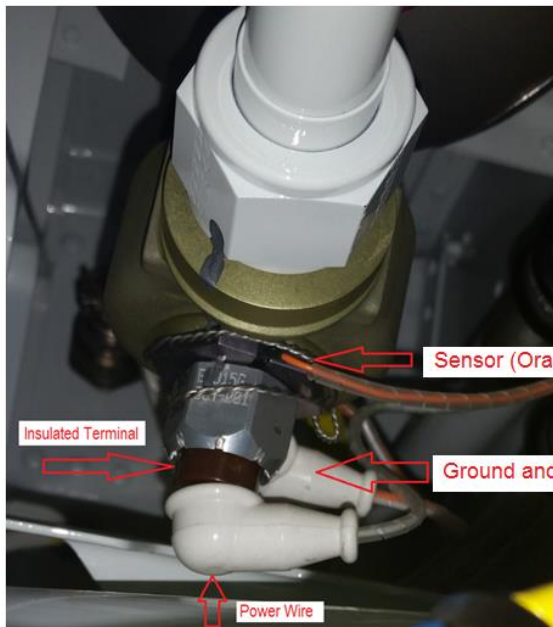
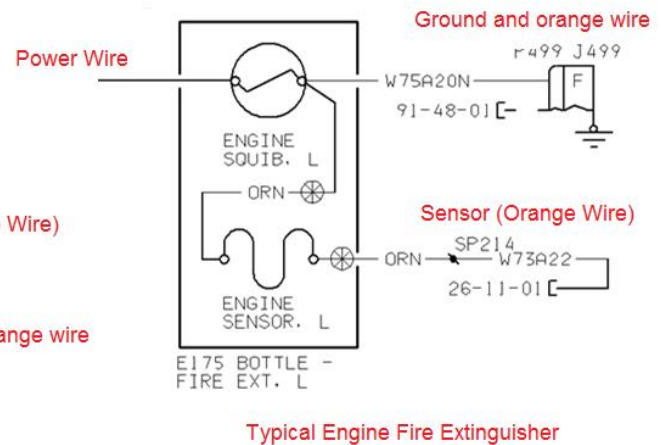
## **ATA 26 - Engine Fire Extinguisher Connections - Revisited**

"Caution should be exercised when attaching the airplane's wiring to the fire extinguisher squibs. The power wire should be connected to the terminal on the insulated end of the squib. The ground wire and the sensor should be connected to the side terminal. Incorrect attachment of the wiring can result in the cockpit fire extinguisher testing "OK" but not firing the squib and causing the circuit breaker to open in the event of the extinguisher button being pushed."

We would like to emphasize that if the wires are connected incorrectly the extinguisher test would still test ok but if the flight crew needed to discharge the bottle the circuit breaker would open instead.

We have included an additional illustration and picture showing the correct connections along with procedures to verify the correct installation of each extinguisher squib wire terminals.

1. For each engine fire bottle squibs the 28 VDC power wire shall be verified by connecting a 28 VDC test light lead to the **removed** squib power wire terminal and the other test light lead to a good fuselage grounded part or screw in the wheel well. Next, press the fire wall valve switch to close the fire wall valve and arm the fire extinguisher. The Fire EXTINGUISHER PUSH light and the test light should both light with low intensity. Next, press and hold the left fire extinguisher switch. The Fire EXTINGUISHER PUSH light should extinguish and the test light should increase in intensity.

- The ground wires shall be tested by connecting one lead of an ohmmeter to the **removed** squib ground terminal wire on each squib and the other lead to a good fuselage grounded part / screw in the wheel well. The resistance value of the ground wire should be close to zero ohms.

If either of the above do not test correctly further troubleshooting and repair is required.

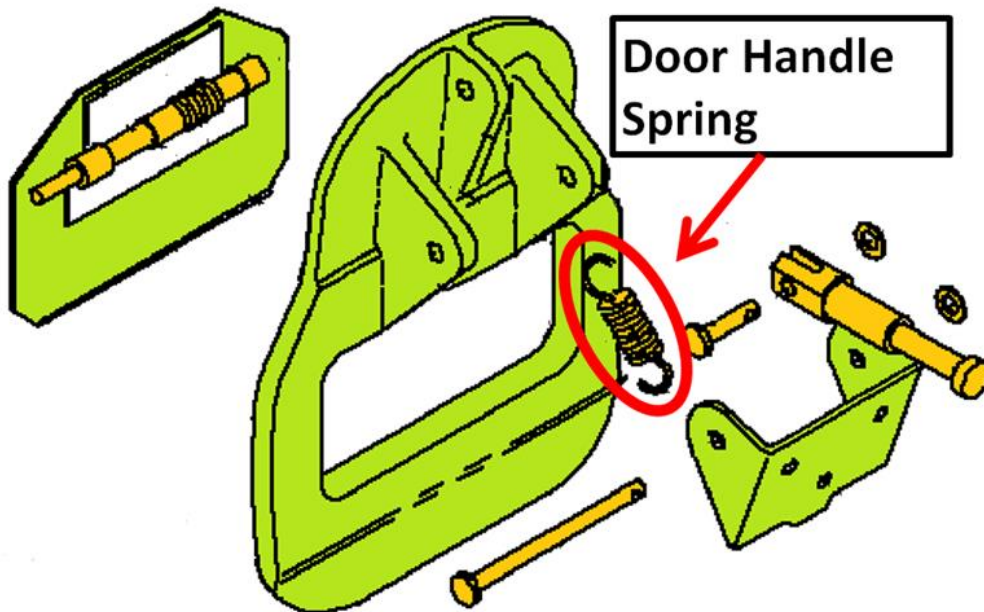
**ATA 52 - Emergency Exit Door Handle Spring**

Due to issues on some King Air 300/B300 and 200/B200 Series aircraft where the emergency exit exterior door handle was reported as not fitting flush with the door, Textron Aviation has approved use of a spring that provides more tension for holding the handle flush. The original 100942H0016-16 spring can be replaced with a 100942H0016-12 that has less active coils and provides more tension for the door handle to stay flush. This spares option will be added to the applicable Illustrated Parts Catalog in future revisions.

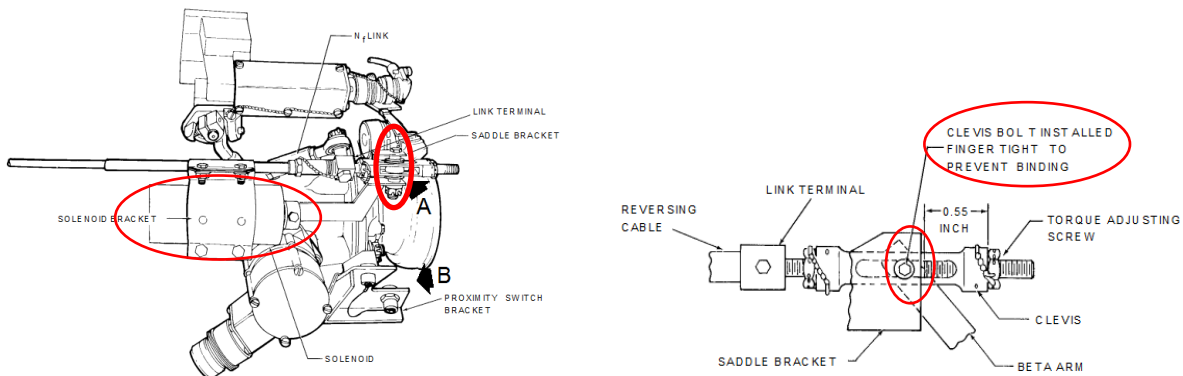
**ATA 61 - Additional Low Pitch Solenoid Cleaning**  
**300/B300 Series**

While troubleshooting the ground idle solenoid it is beneficial to clean any possible contaminants from the internal bore of the solenoid. Following find a step by step procedure to do so:

- (1) Disconnect reversing lever attach bolt and remove plunger from solenoid. Note hardware stack up and retain hardware.
- (2) Clean plunger and solenoid bore with solvent. Do not use electrical contact cleaner.

- (3) Install plunger and connect reversing lever attach bolt using retained hardware and new cotter pin.
- (4) Inspect wiring and associated linkage for damage, chafing, and attachment.
- (5) Perform ground run and verify that ground and flight idle torques are within parameters detailed in ground performance worksheet using applicable maintenance manual.
