Multi-Engine Turboprop Communiqué**Communiqué ME-TP-0020
June 2020****ATA 25 – AmSafe Crew Seat Belts Connector Web Slide Insert**
Aircraft equipped with AmSafe Crew Seat Belts

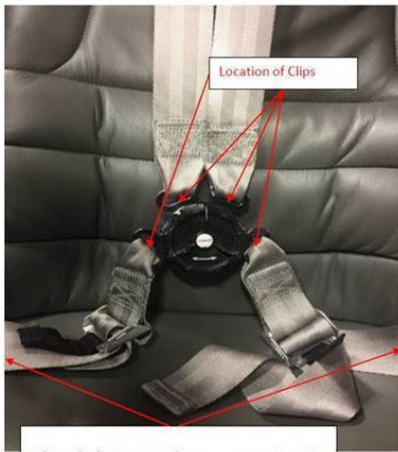
Location of Clips

Where the harness attaches to seat securing point there are no clips by design and buckle bolted to seat is same type as used where there are clips.

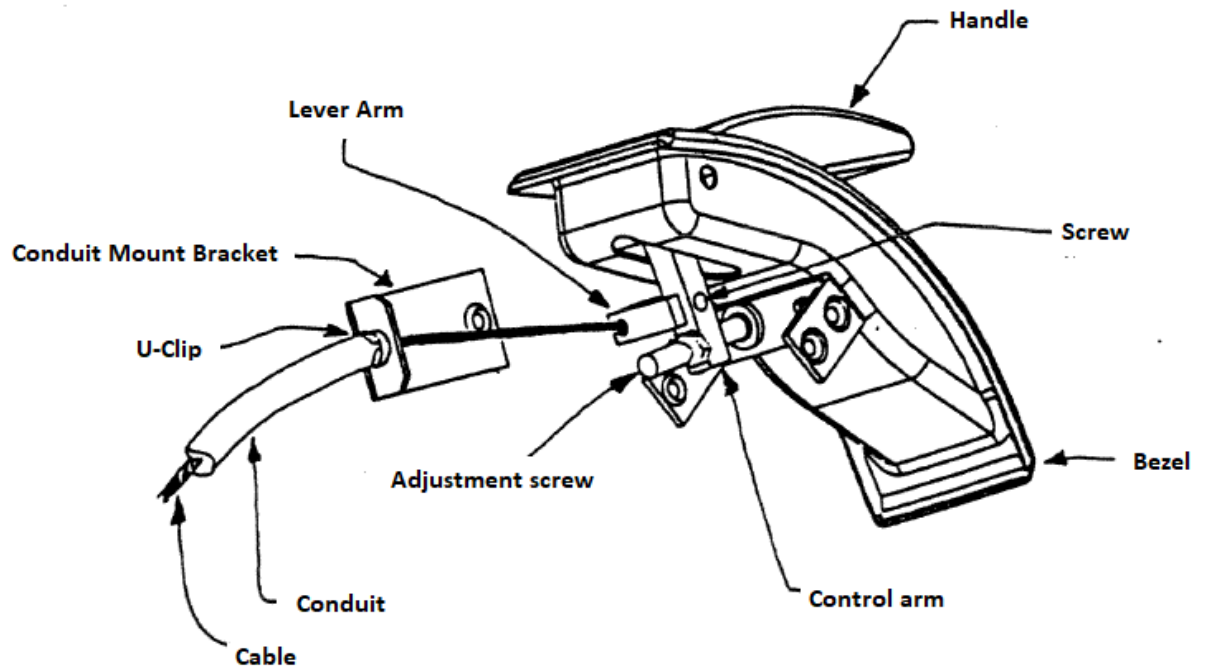
The Aircraft Modular cabin seats (P/N 2524.014.01 Series) use a swivel mechanism activated by a cable which attaches to the seat swivel level on the arm rest. The parts associated with this mechanism are as follows:

1. Conduit P/N SP2018245
2. Wire P/N MC09780-00
3. Crimp P/N 403B-051
4. Clip P/N 2000-25-STZD
